## STUDY AND EVALUATION OF SOIL SLOPE STABILITY OF AL- MASAB AL-AAM CHANNEL (MIDDLE SECTOR) OF IRAQ

### ABSTRACT

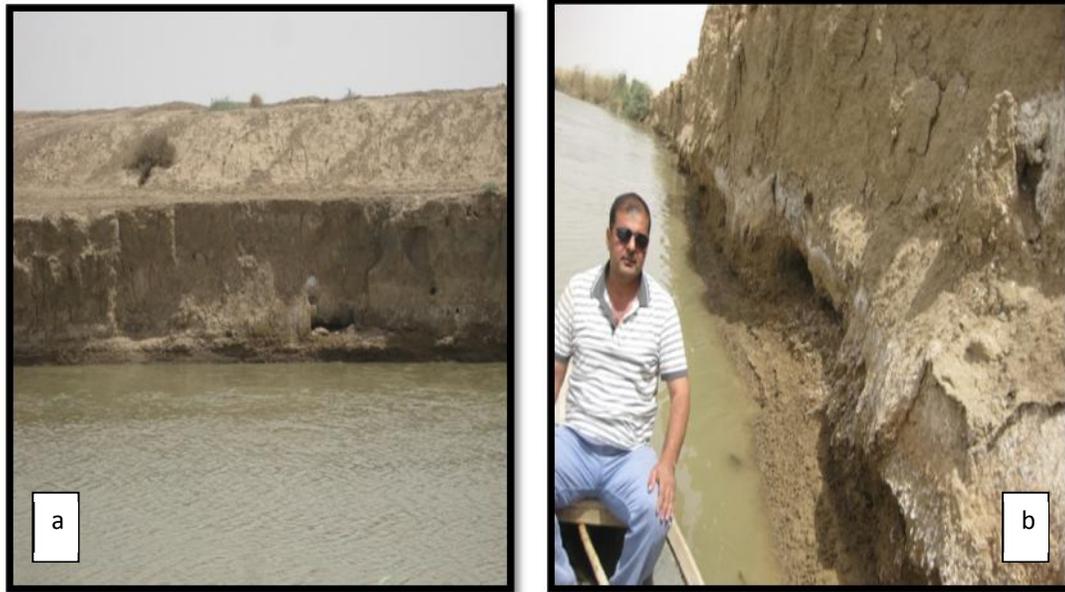
of sandy silty clay,(CL), it was collected from the lower part of the slope which is close to the water surface .The soil has brown color, medium hardness , low plasticity and moisture content of (19.6%). This station is one of the unstable sites, where(1)salt layers are observed in the lower part of bank close to the

water surface (2)there are many soil slabs with observed failure of soil masses (probably sliding and fall )close to the bank slope toe indicating soil detachment as in plate(1).

Plate(1) Showing (a) General front view of the bank slope at station No.(1) in the Al-Massab Al-Aam channel (middle sector).Photo direction is NE. (b)Close side view of the salt layers, and soil slabs failure sliding and fall in the lower part of the bank slope at station No.(1)

This station is one of the unstable sites, where(1)salt layers are observed in the lower part of bank close to the water surface (2)there are many soil slabs with observed failure of soil masses (probably sliding and fall )close to the bank slope toe indicating soil detachment.

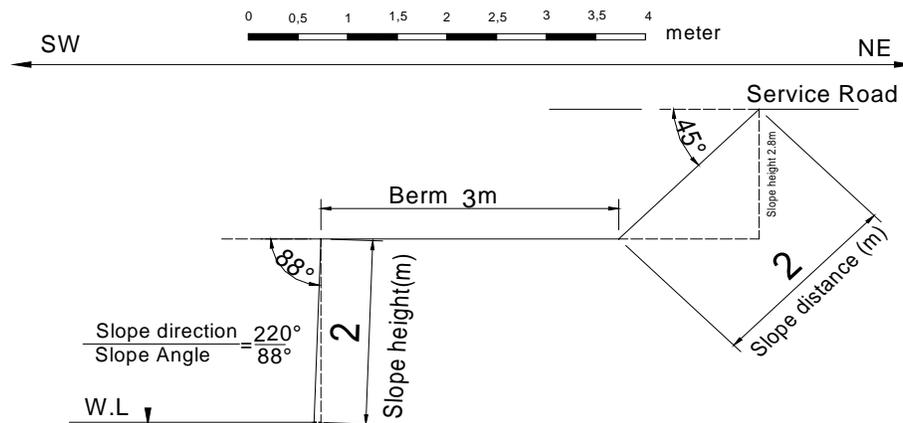
Governorate .It represents the beginning of the study area and it is called station (365+00)area , (Fig.1 and plate1).The bank slope inclination is (220°/88°-OH) and slope height is (2.5)m.(Fig. 2) shows vertical profile perpendicular to the bank slope trend at station No(1).It shows from bottom upward the following parts:(1)the main vertical bank slope partially overhanging which is 2.5m high (2)the horizontal berm which is 3m wide (3)soil slope inclined 45° SW, which is 2.8m high, and (4)horizontal service road. The soil at this site is composed

Figure (2) Vertical profile perpendicular to the bank slope trend at station No(1) in the Al-Massab Al-Aam channel (middle sector ).

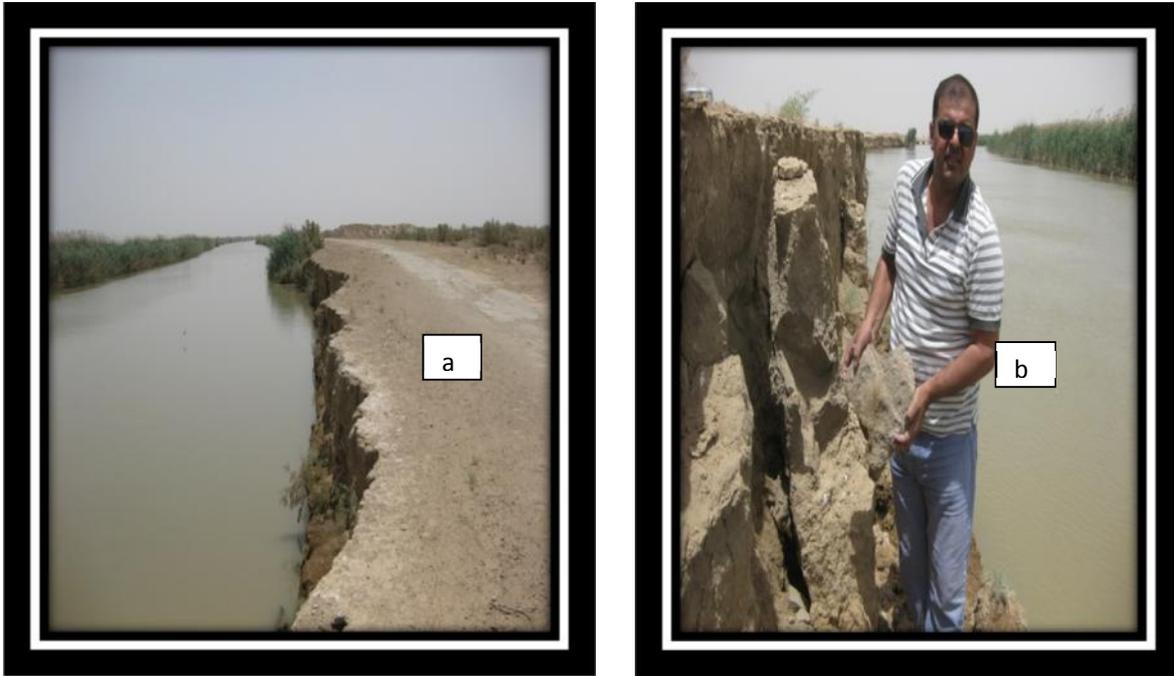
This station is one of the unstable sites, where observed failures include tension crack ,toppling and soil fall of soil masses close to the bank slope toe as in plate(2).

plate(2) Showing views of the bank slope at station No.(2)in the Al-Masab Al-Aam channel(middle sector). (a) General side view of the bank slope. Photo direction is

SE. (b)Close side view of the failed bank slope showing detached soil blocks. Photo direction is NW.

This station is one of the unstable sites, where observed failures include tension crack ,toppling and soil fall of soil masses close to the bank slope toe is 0.5m thick.

1. The soil cement mixture can be used for casing the drainage and irrigation channels in Al-Massab Al-Aam channel where most drainage which is flow in the Al-Massab Al-Aam channel causes water erosion and bank slopes failures therefore must be stabilizing it especially in station.
2. Lime stabilizations technology can be used in some stations of Al-Massab Al-Aam channel especially station
3. The riprap methods generally used for casing the bank slopes which had highly erosions such as the meanderings rivers and the locations of meeting the Al-Massab Al-Aam channel (middle sector) with its branches, therefore this method can be used in some stations especially stations(2,4).

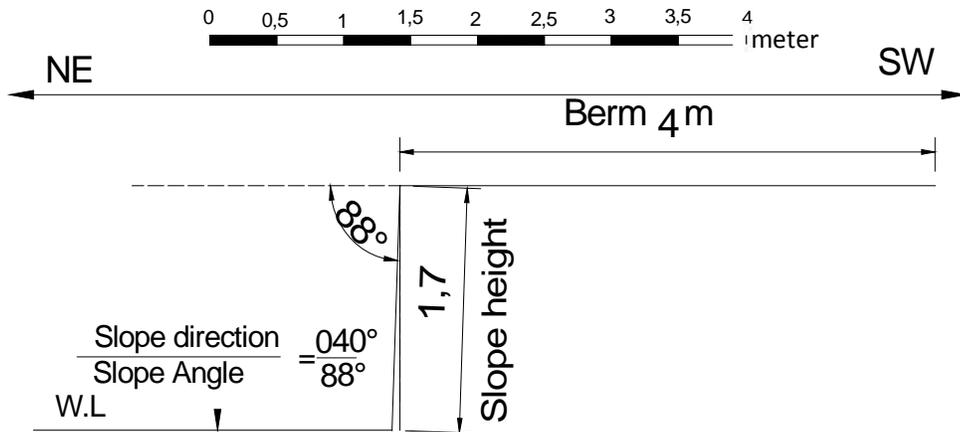
**Figure (3)** Vertical profile perpendicular to the bank slope trend at station No(2) in the Al-Masab Al-Aam channel (middle sector).

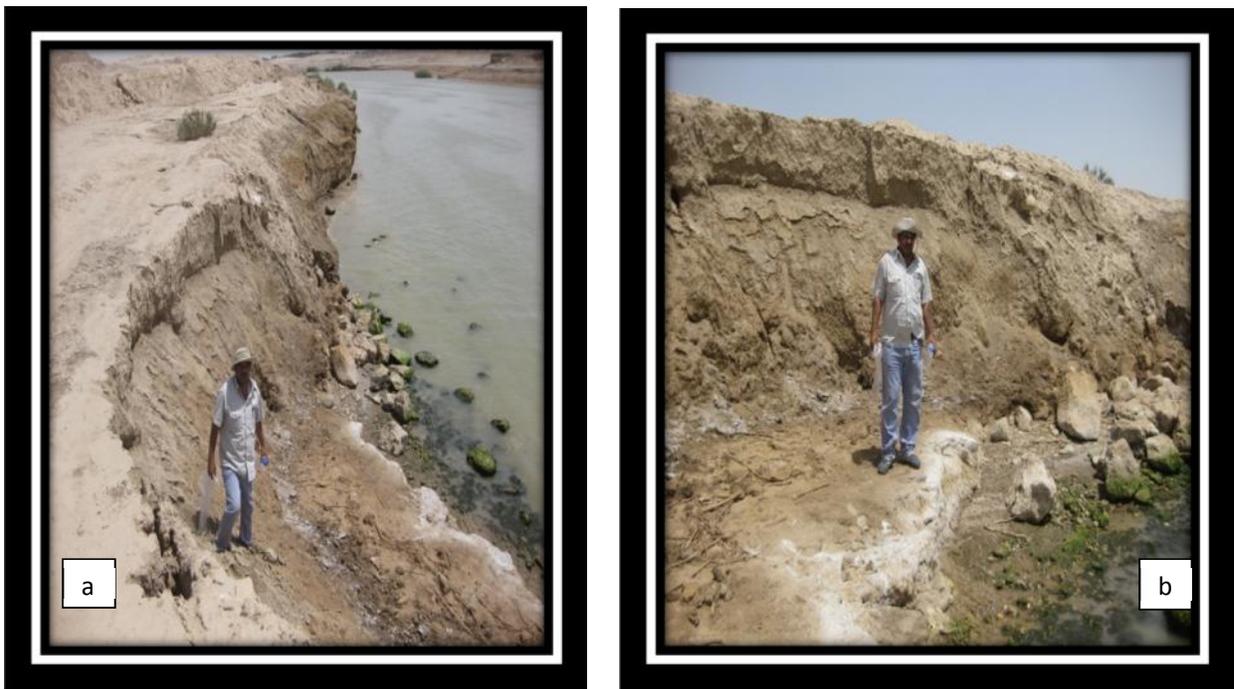
above(2)the horizontal berm which is 3m wide(3) soil slope inclined 45° SW, which is 2.1m high, and (4)horizontal service road. The soil at this site is composed of silty clay,(CH) it was collected from the lower part of the slope which is close to the water surface .The soil has brown color, medium hardness , high plasticity and moisture content of(21.2%). This station is one of the unstable sites, where the observed failures include tension crack ,detached soil blocks from the upper hard soil layer as seen in Plate(3 ).

plate(3) Showing views of the bank slope at station No.(3) in the Al-Massab Al-Aam channel (middle sector). Photo directions are NW.(a)General side view of the bank slopes showing the lower inclined slope (2m high)and the upper

vertical slope of salty layer gypsam)(b)Close side view showing the lower inclined and the upper vertical slopes with fallen detached blocks from the upper hard soil.

This station is one of the unstable sites, where the observed failures include tension crack, detached soil blocks from the upper hard soil layer.

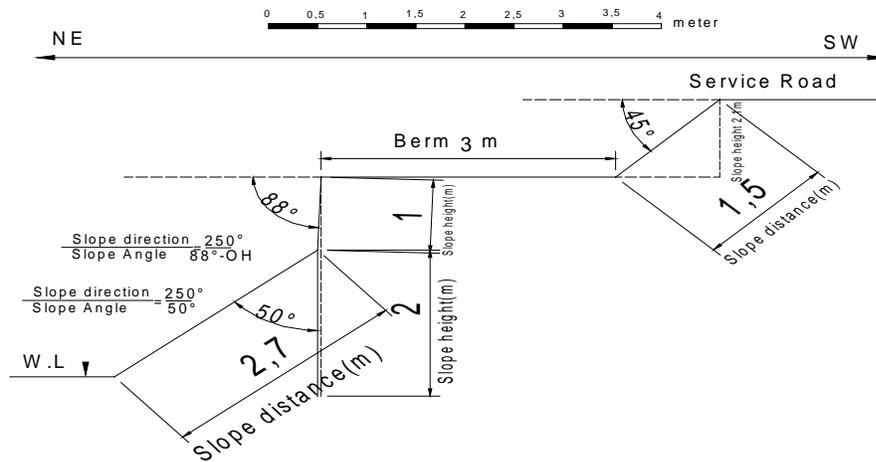
**Figure (4)** vertical profile perpendicular to the bank slope trend at station No(3) in the Al-Massab Al-Aam channel (middle sector).

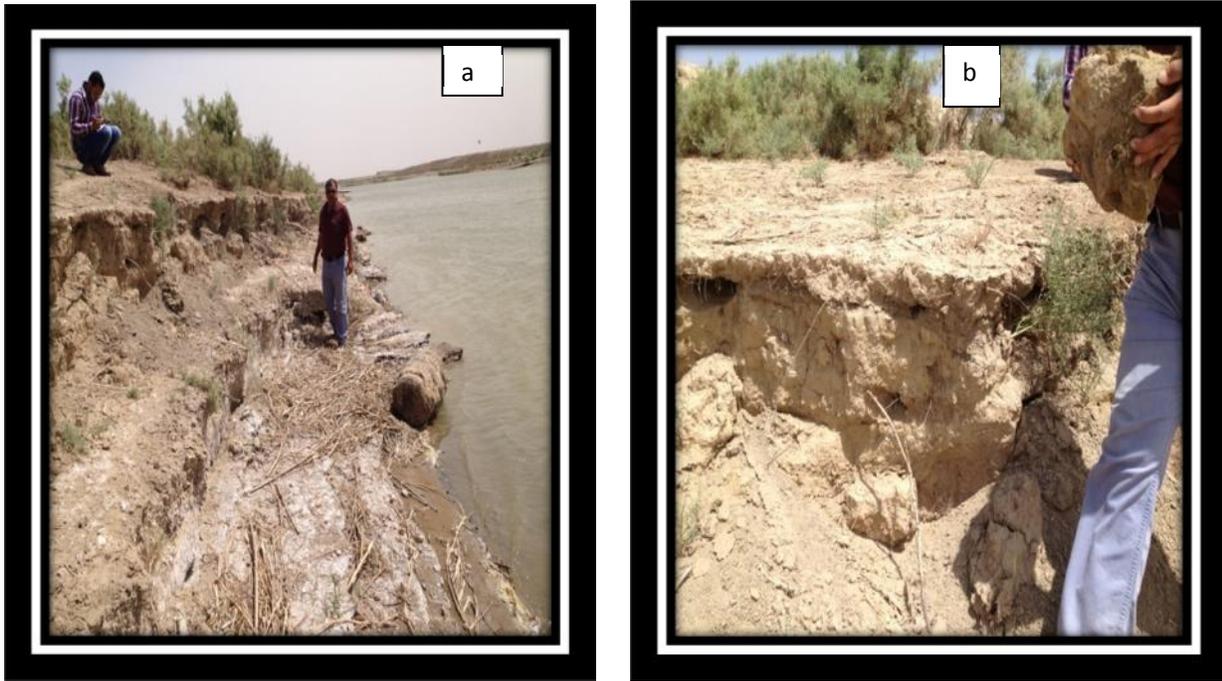
This station is one of the unstable sites, where (1) salt layers are observed in the lower part of the bank close to the water surface (2) slope failure includes local disintegration of different layers with detached soil blocks by fall or toppling as in Plate(4).

plate(4) Showing general views of the bank slope at station No.(4) in the Al-Masab Al-Aam channel (middle sector), (a)side view showing the stepped bank slope like stream terraces in form but with different origin (wave

erosion). Photo direction is SW.(b)Front view of one step (layer)in the upper part of the slope showing detached soil blocks .

the water surface (2) slope failure includes local disintegration of different layers with detached soil blocks by fall or toppling.

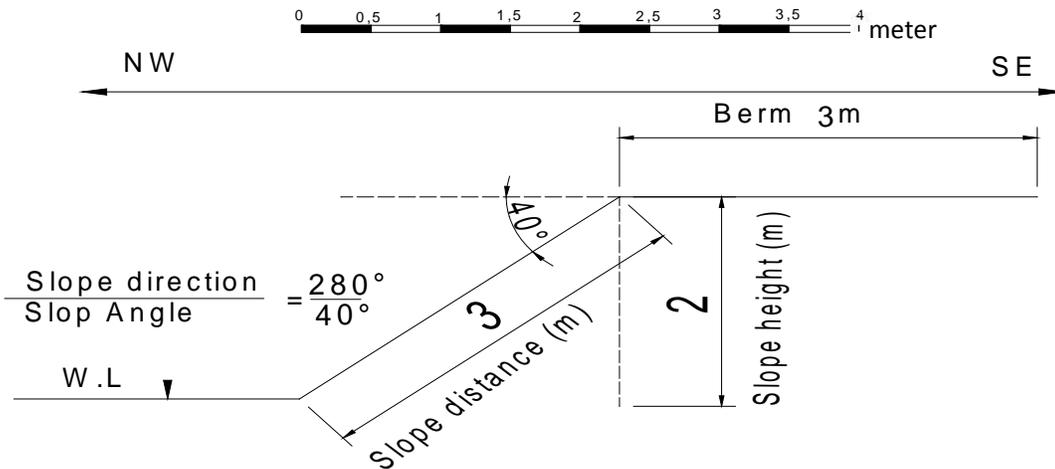
**Figure (5)** Vertical profile perpendicular to the bank slope trend at station No(25) in the Al-Masab Al-Aam channel (middle sector).
