THE IMPACT OF ENVIRONMENTAL AND SOCIO-ECONOMIC ACTIVITIES ON LAND COVER/LAND USE PATTERNS OF AUCHI, EDO STATE, NIGERIA.

The impact of environmental and socio-economic activities on land cover/land use patterns of Auchi

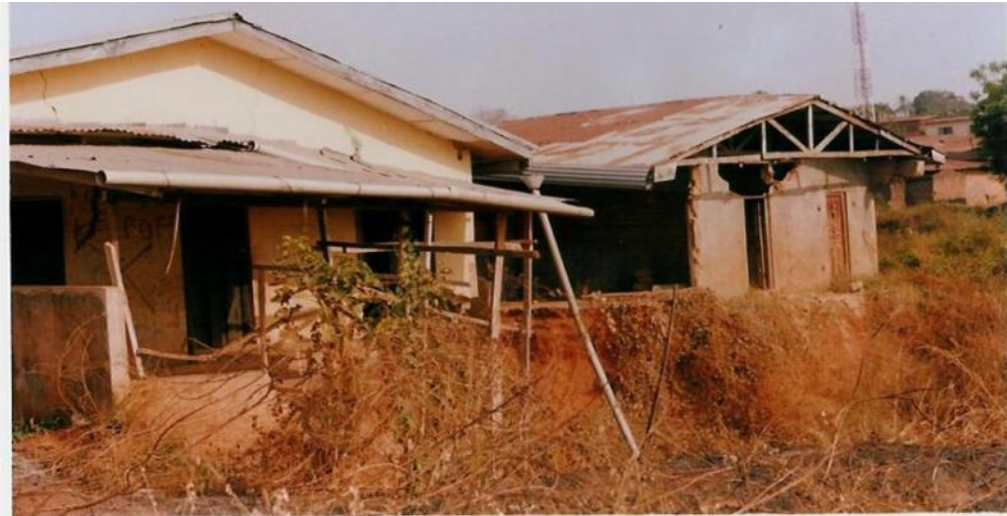
Plate 1: Erosion threat to residential land use at Iyekhei quarters

Transportation: This land use is very small compared to the area of land occupied by the built-up land. It includes motor parks and right of ways which accounts for 1.21%. The difference between the standard coupled with the population growth accounted for the traffic land use problem within the township area. A host of the aforementioned roads within the study area can hardly accommodate any physical expansion without demolition of existing physical structure (Plate 1). Considering the

As expected, a number of problems have been created by this development. The hitherto vegetated hillsides have been cleared for development thereby exposing the land to the menace of soil loss through the process of erosion. The major type of erosion found in this area is gully which excavates both the top-soil and sub-soil through the process of scooping which are visible in notable areas like Warake road, part of Water Board to mention a few. Buildings are being threatened (Plates 3, 4, 5 and 6). Associated lowland flooding of Usogun, Akpekpe and some Iyekhe areas is prevalent.

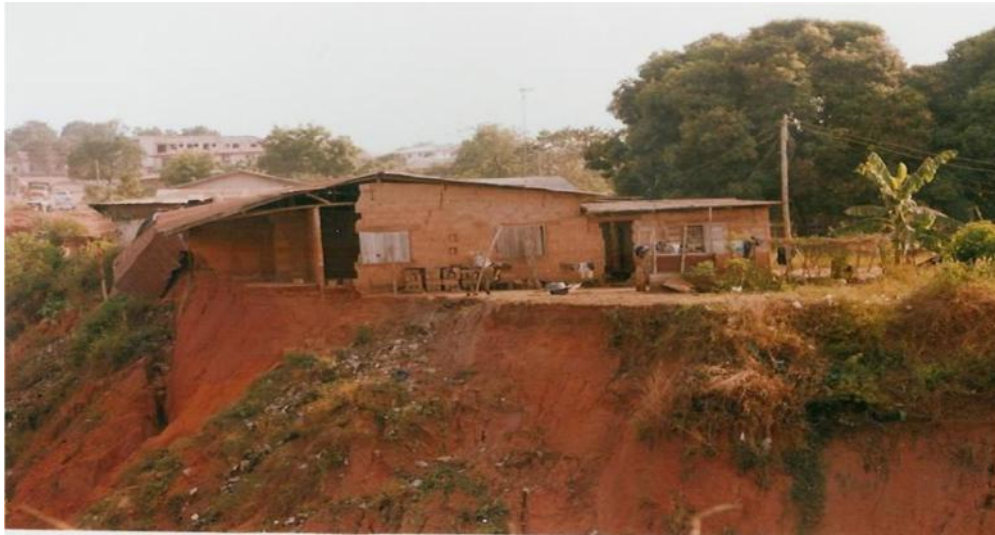
Plate 2: Erosion threat to residential land use at Usogun Quarters

cracks in the walls of some houses due to the damage done to their foundation by soil erosion (Plates 2, 3, and 4). As a result of these damages, lives and properties of the inhabitants are seriously threatened.

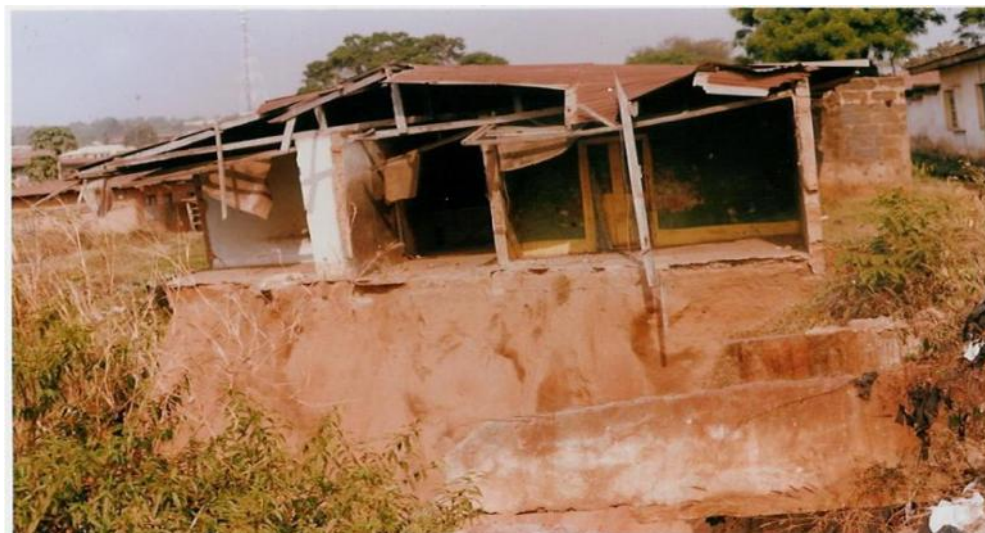
Plate 3: Residential Land Use Totally Destroyed By Soil Erosion At Akpeke Quarters

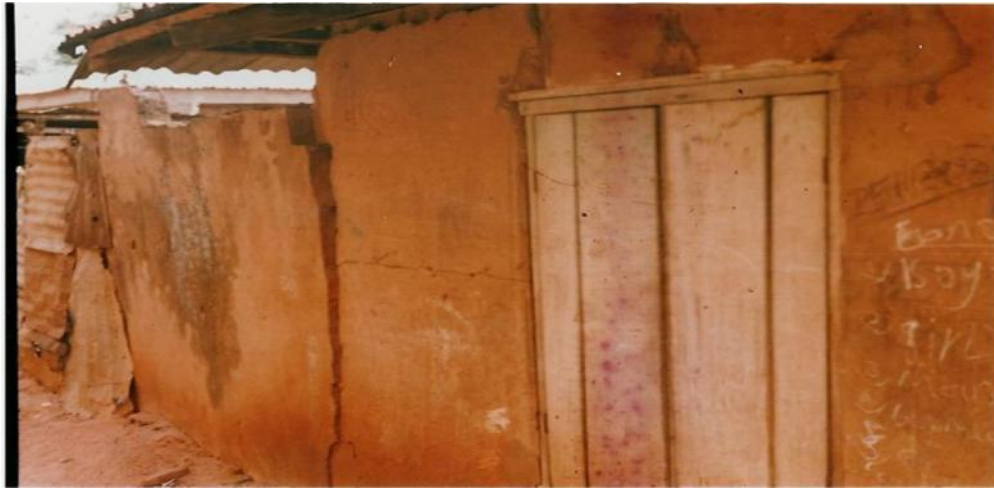
Plate 4: Cracks on Residential Land use at Igbei Quarters

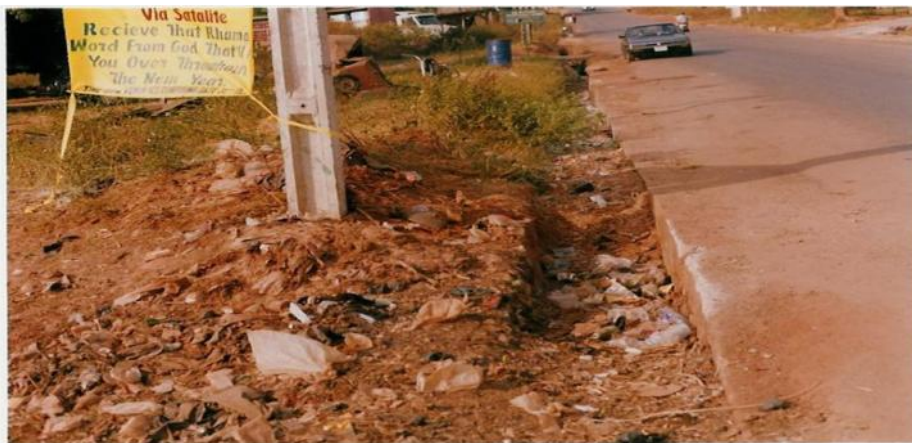
Plate 5: Drainage Blocked by Solid Waste

Presently, there is one main market in Auchi; the Uchi market. People from the surrounding communities come and buy their needs in this local market. The commercial area either lack drainage facilities or the existing ones are not maintained (Plate 5). Thus existing drainage system and the roads are blocked with refuse and debris from the market. As a result during the raining season a lot of perishable goods are damaged by the run-off water. In some cases, the commercial activities are completely paralysed for a greater part of the day. Some parts of the market have been eroded and completely abandoned by
